# THE MANNERHEIM LINE 1920–39

Finnish Fortifications of the Winter War

**BAIR IRINCHEEV**

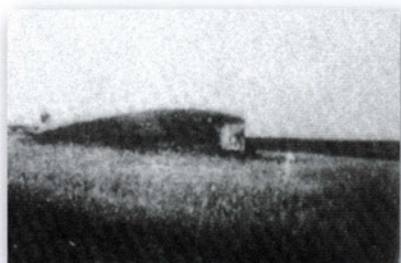
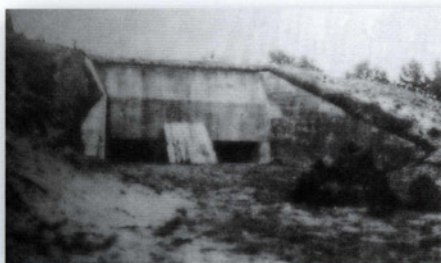
Noisniemi artillery fort on the Vuoksi River, photographed by a Soviet spy in the late 1920s–early 1930s. A map and photo album of Finnish fortifications on the Karelian Isthmus was produced by the Red Army Central Intelligence Bureau in the USSR in 1937. However, by 1939 the album was obsolete, as the Finns had built many more bunkers between 1937 and 1939. (Antero Uitto)

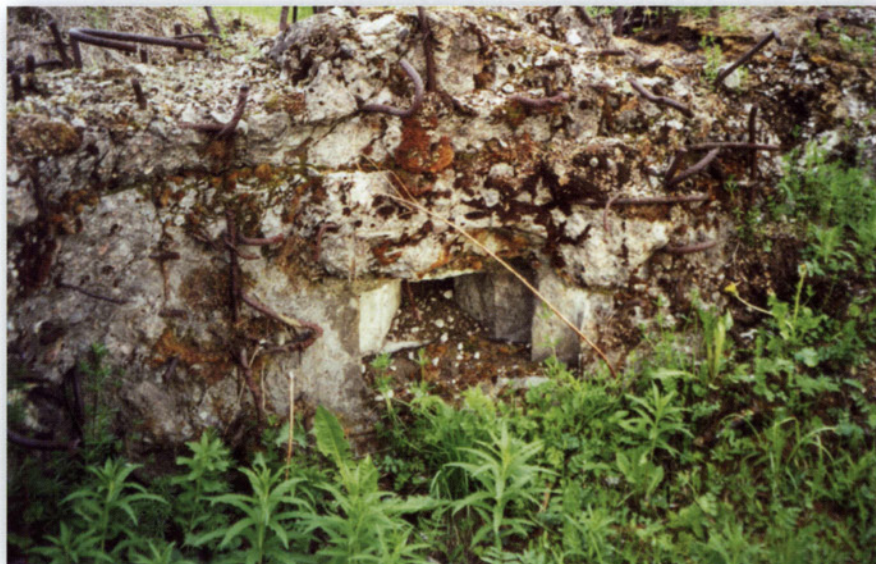
A gun-port for close-range combat in the Sk5 bunker, suited to a Suomi sub-machine gun or a Lahti-Saloranta light machine gun. (Bair Irincheev)

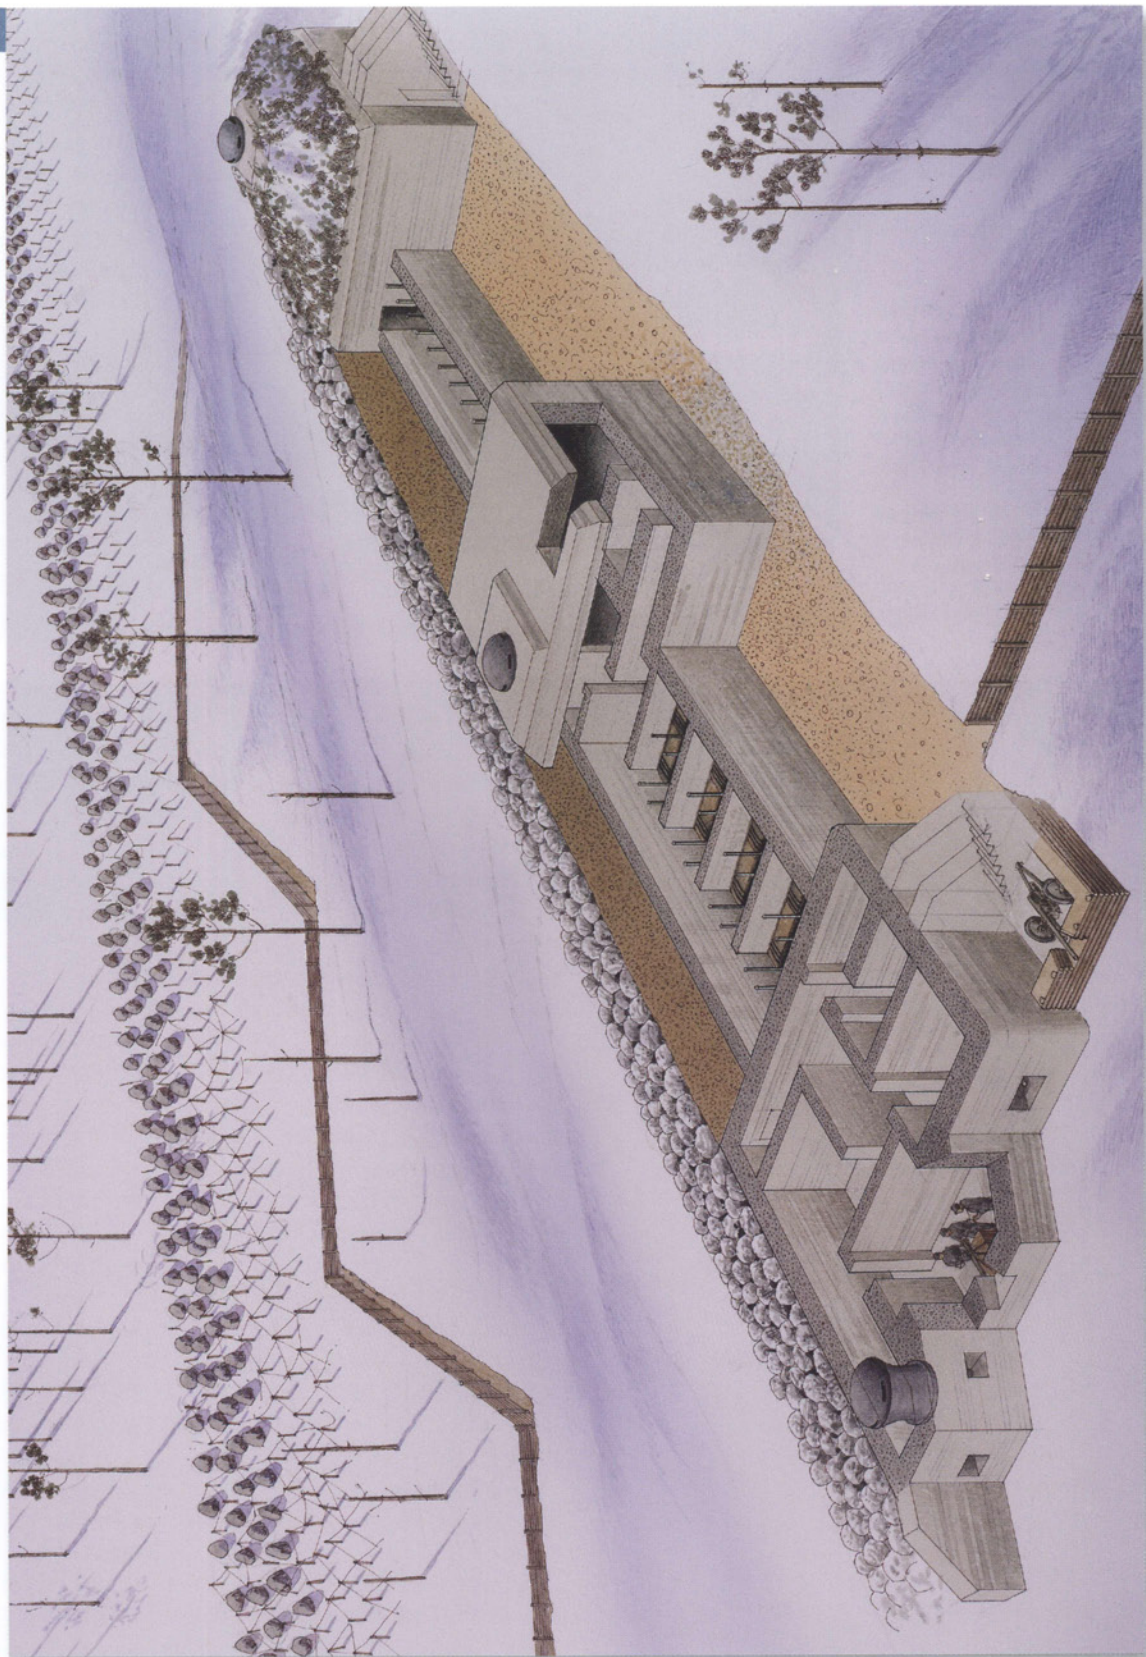
The SJ5 'Millionaire' (in Finnish, *Miljoonalinnake*) bunker was the most famous of all the fortifications of the Mannerheim Line. This reconstruction is the first ever to be attempted of the whole site around the bunker. The bunker was about 60m long, and was equipped with four heavy machine guns set up for flanking fire, and had three armoured towers for

observation and close combat. It could accommodate 20–40 men in the underground shelters, and had three casemates. This bunker was built between 1937 and 1939, as part of the last efforts to strengthen the defences of the isthmus. The bunker is shown as per December 1939, before the fighting in this sector.

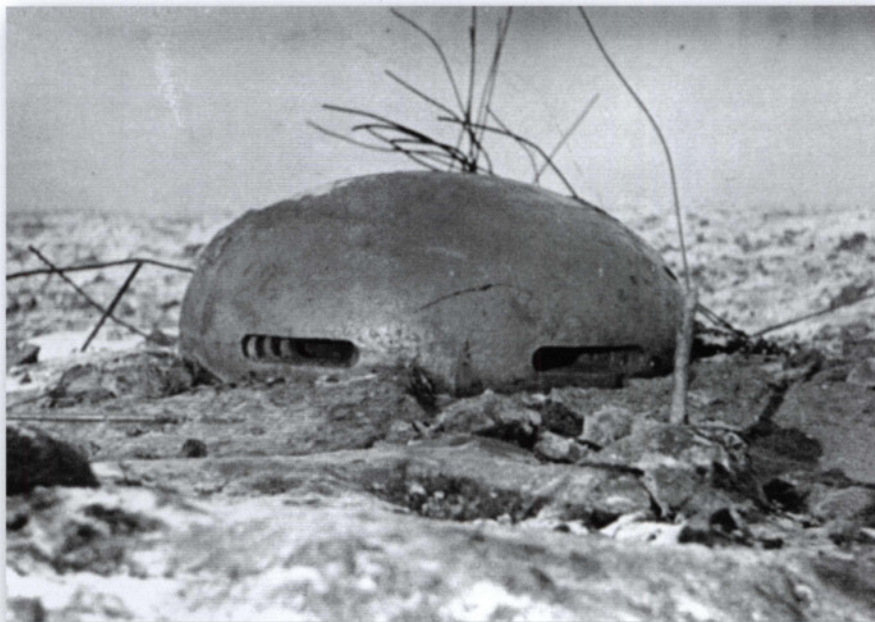
#### RIGHT

An intact armoured tower on a Finnish bunker. Note the protection for shell splinters on the observation and close-range defence slits. (Carl-Fredrik Geust)

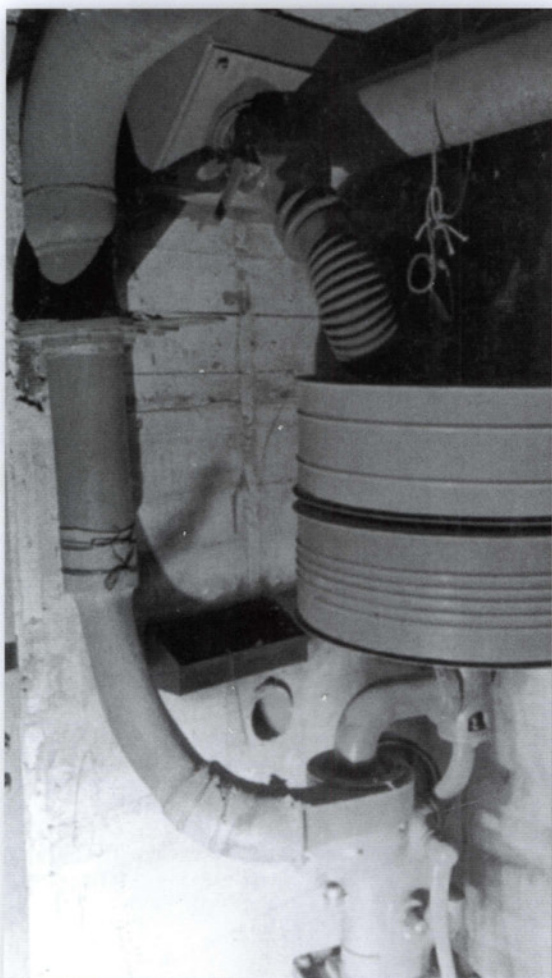
#### BELOW

The standard air ventilation system of a Finnish bunker. A handle for circulating the air can be seen in the lower part of the picture. (Carl-Fredrik Geust)

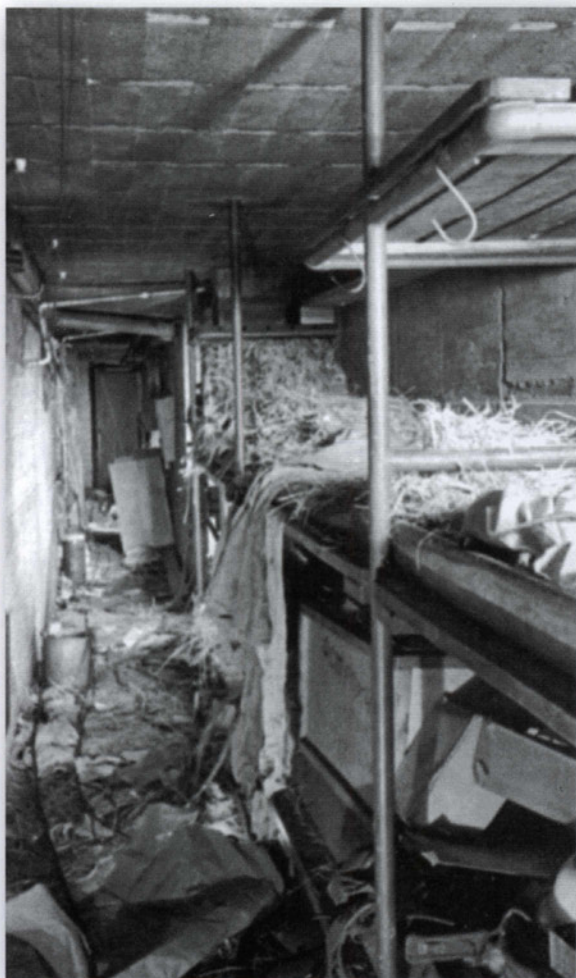
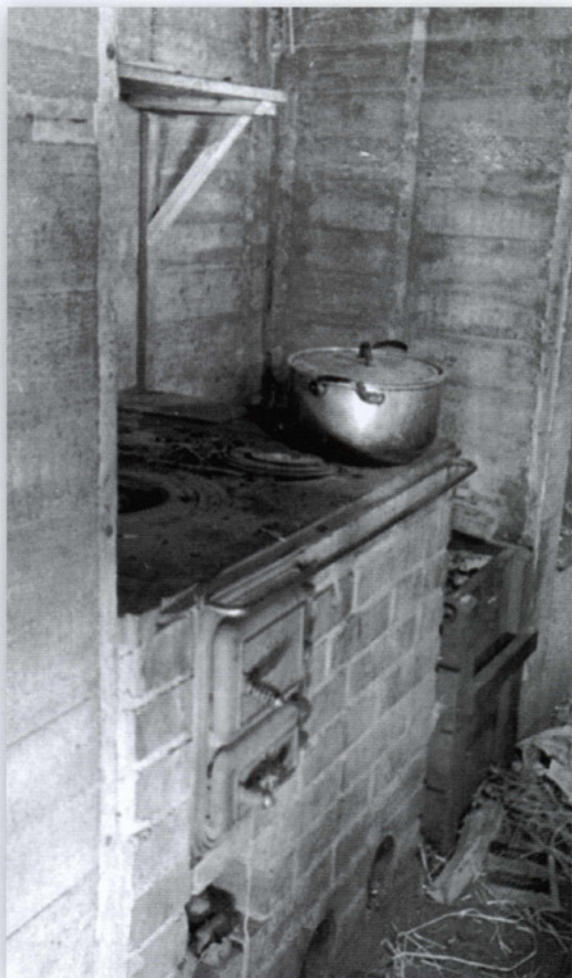
A stove for heating and cooking food inside a bunker, most likely Sk10 'The Ten'. (Carl-Fredrik Geust)

The badly damaged frontal armoured wall of a Finnish armoured bunker, probably Le6 or Le7. Note the two wide observation slits and the narrower gun-port below them. (Carl-Fredrik Geust)

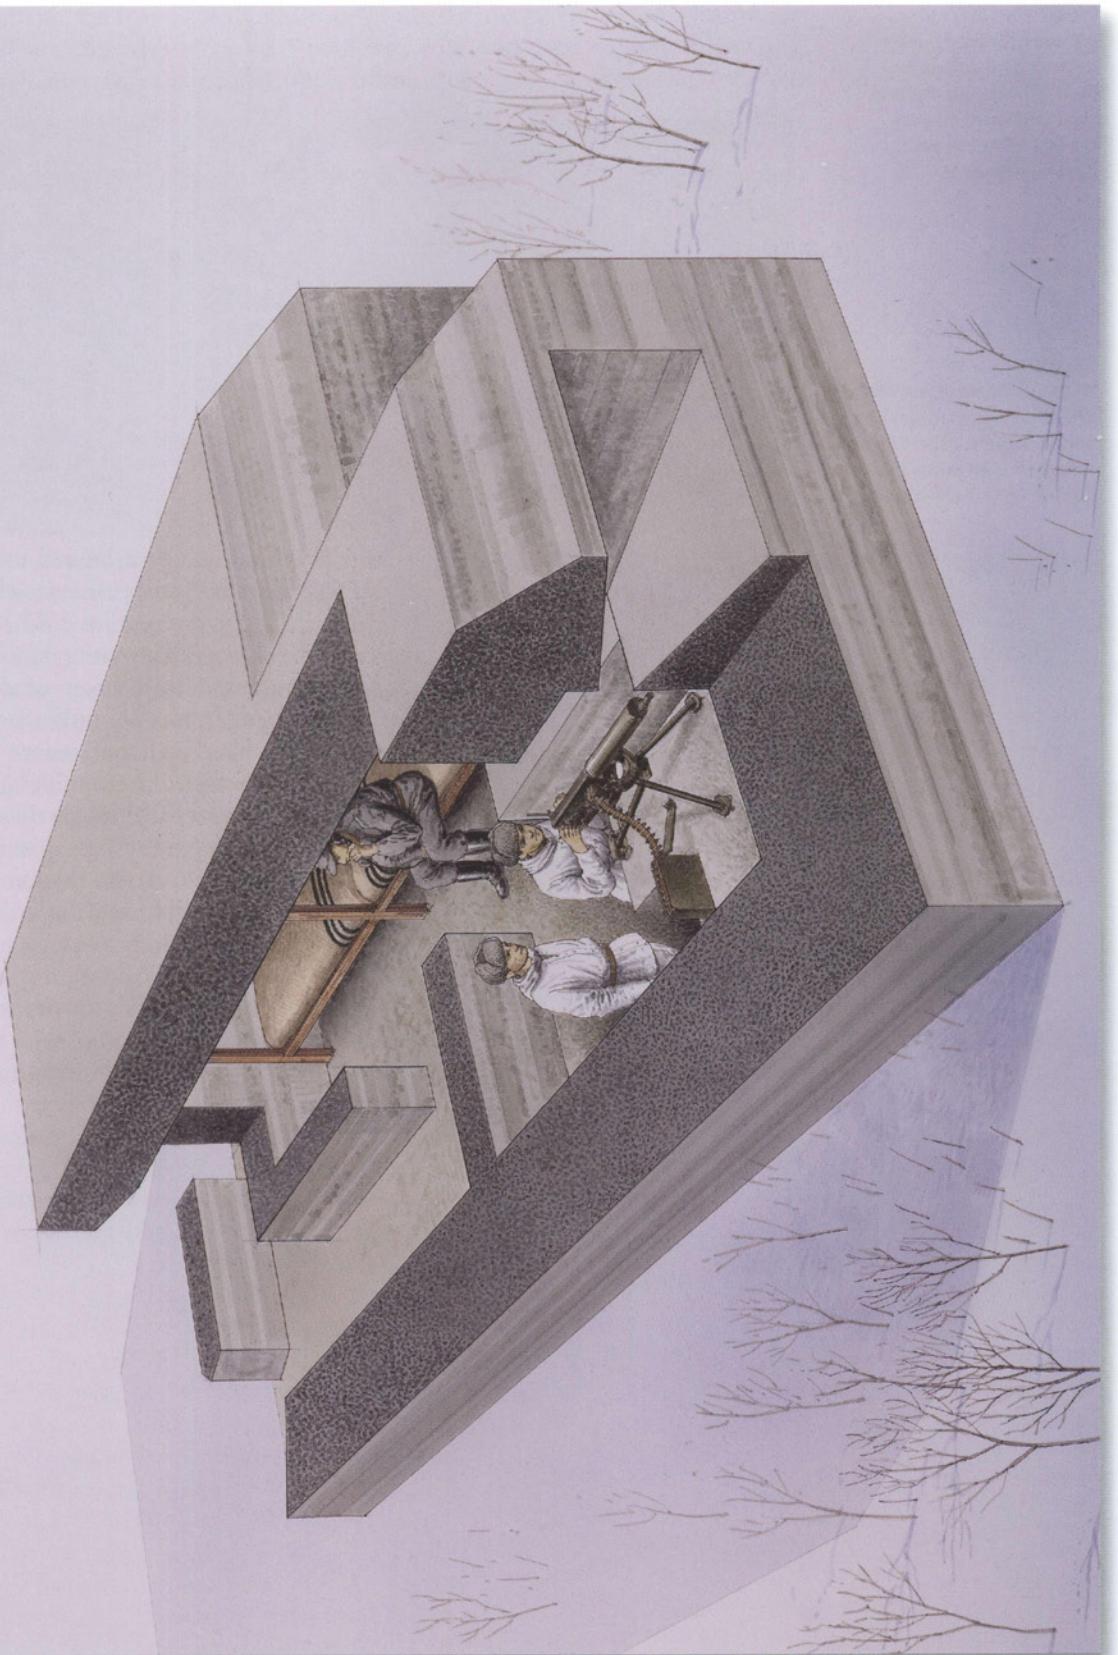
This type of bunker was the most prevalent among the defences of the Mannerheim Line. The bunker was located to the west of the Terijoki–Koivisto railway line, and was made of concrete. Its weaponry comprised one Maxim heavy machine gun, mounted on a standard Finnish Army tripod. The latter was

placed directly onto a concrete shelf below the embrasure. It appears that the bunkers did not even have any doors on them. In 1939 these bunkers were mostly obsolete, and being clearly visible in the terrain they fell easy prey to Soviet artillery.

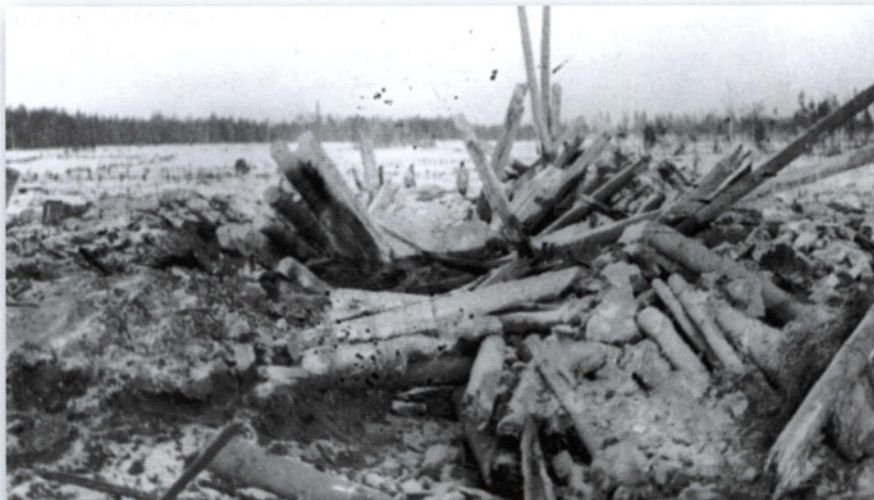
**RIGHT**

A Finnish wooden bunker destroyed by a direct hit from Soviet heavy artillery, in an unknown sector of the Mannerheim Line. (Carl-Fredrik Geust)

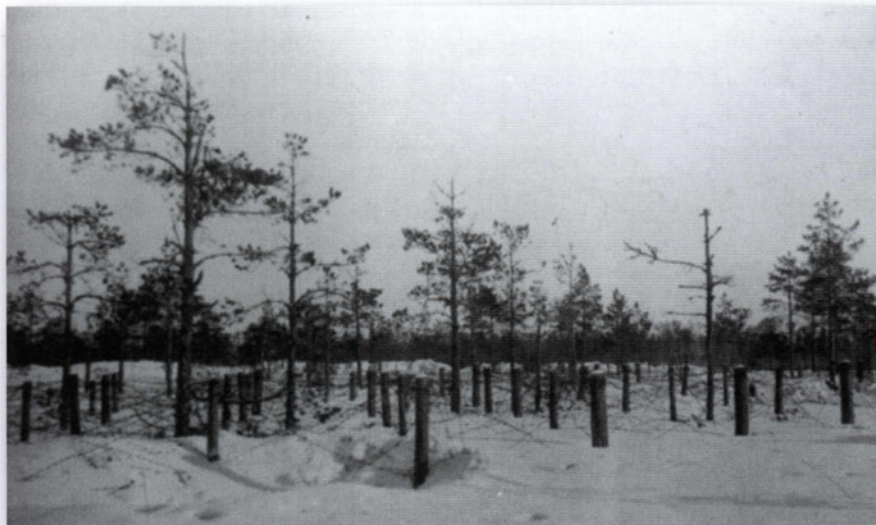
A barbed-wire obstacle line in an unknown sector of the Mannerheim Line. (Carl-Fredrik Geust)

Barbed-wire entanglements and fences were the most common infantry obstacle on the Mannerheim Line. Several variations were noted in different sectors of the Line. The Lähde and Salmenkaita sectors had barbed wire attached to spear-like steel poles, which were only 30–40cm above the ground. The overall length of the poles was about 1.5m long, so the poles were very firmly driven in. In winter, with the snow level reaching 50–100cm, these barbed-wire fences would become invisible and the Red Army infantry only became aware of them when they were already entangled. In some cases these low barbed-wire fences were combined with an anti-tank barrier made of rocks. Some fragments of these barbed-wire obstacles can still be seen today, and are especially prominent in the Lähde sector.

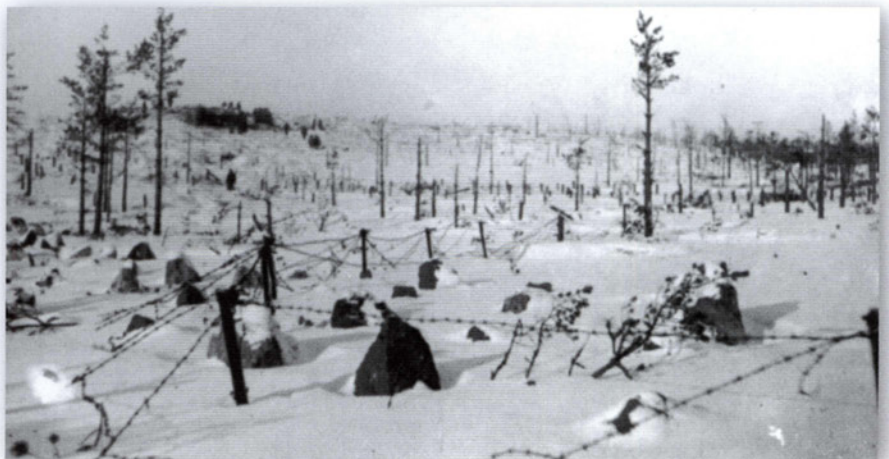
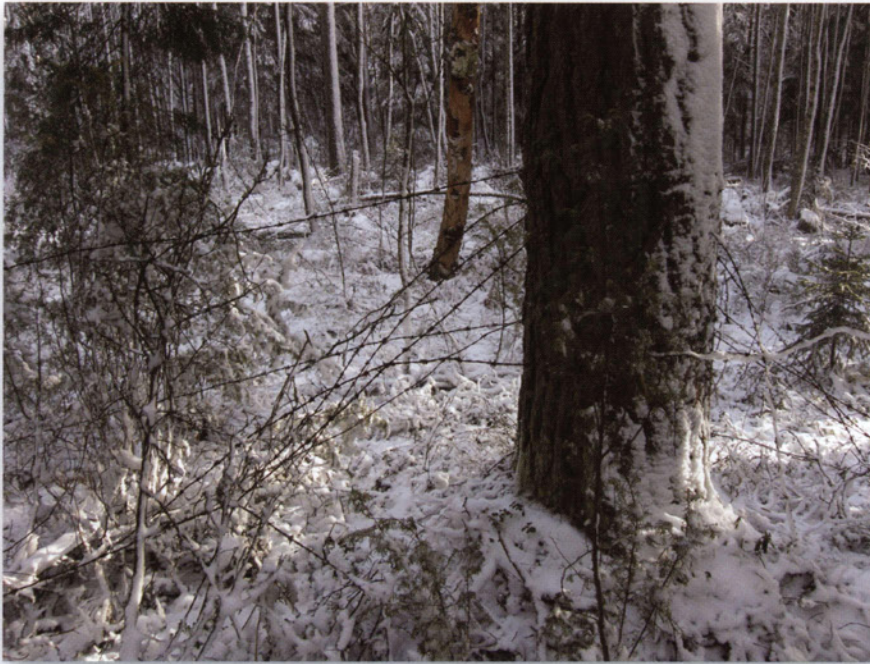
A barbed-wire obstacle line, attached to steel poles, combined with an anti-tank rock barrier. The second row of barbed wire can be seen in the distance. The dark object in the background is the Sjs 'Millionaire' bunker. The photo was taken in the Lähde sector of the Mannerheim Line. (Carl-Fredrik Geust)

A modern view of a barbed-wire obstacle attached directly to trees, in the Inkilä sector of the Mannerheim Line. In the 60 years since the war ended, the barbed wire has grown into the trees. (Bair Irincheev)

Another variant of the barbed-wire fence saw the attachment of barbed wire directly to living trees. Such obstacles were hard to spot and were normally built between strongpoints to prevent outflanking and infiltration of the Line by Red Army scout parties. These barbed-wire fences can still be seen in the forests, as most of the trees are still growing there.

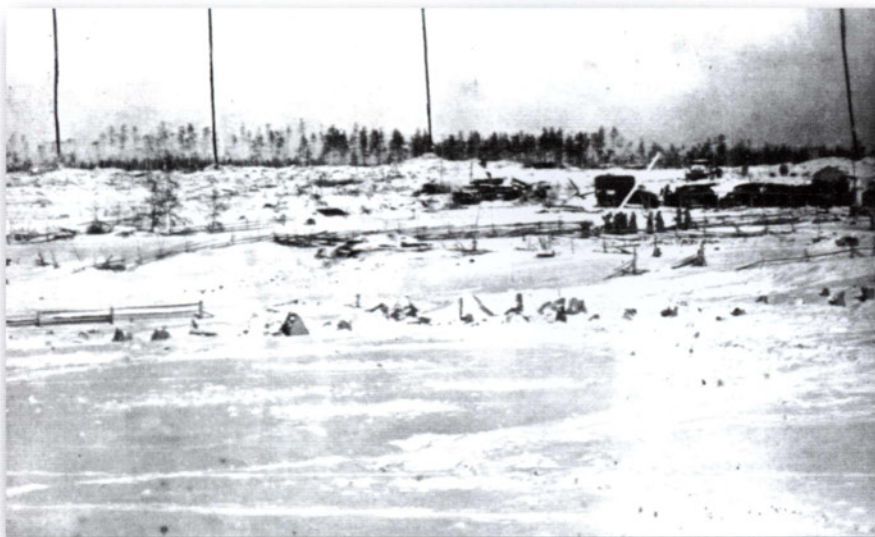
A view of Summa village after the fighting. Soviet cars and trucks are parked in the former no-man's land. An anti-tank obstacle line is visible in the foreground. Two destroyed T-28 tanks are also visible in the centre of the picture. The Finnish bunkers are marked by vertical black lines. The picture was taken from a Soviet artillery forward observation post. (Carl-Fredrik Geust)

The second serious failing of the Finnish anti-tank defences was where they were placed – namely, in front of the Mannerheim Line in open ground, where they were clearly visible from the Red Army side. This enabled the latter to employ both direct and indirect artillery fire in order to clear passages through them. In addition, the Soviet tanks themselves could clear a way through the lines by firing their main guns at the boulders; a 45mm tank cannon could destroy a rock with one direct hit.

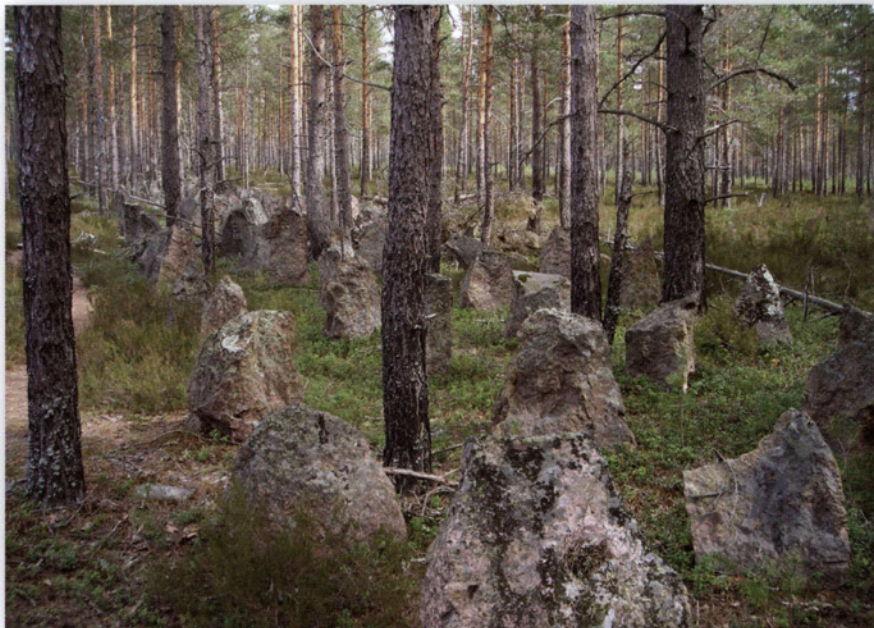
A modern view of the anti-tank obstacles in Lähde sector, not far from the Sjö 'Millionaire' bunker. (Bair Irincheev)

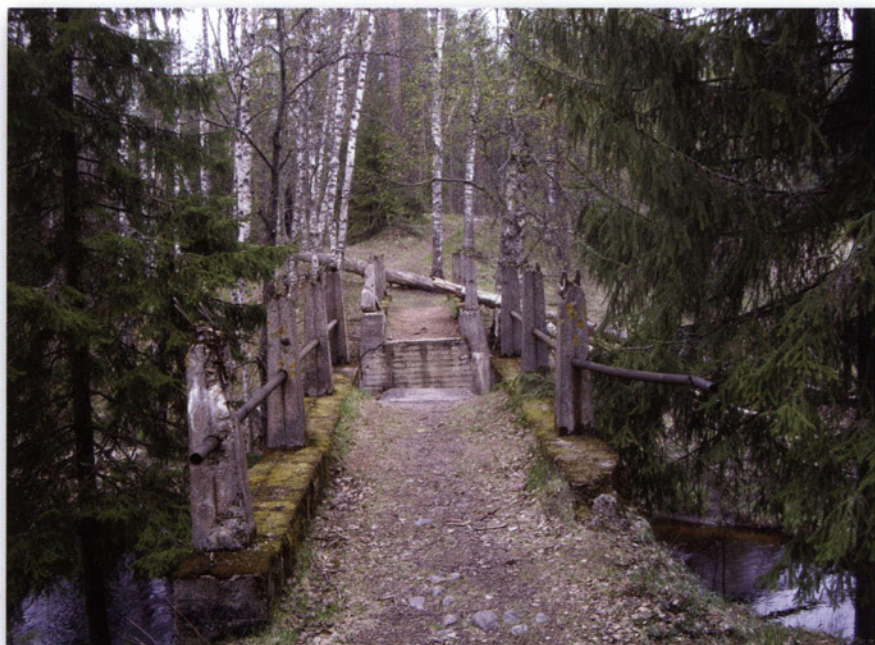
A destroyed flood dam in the Leipäsuo sector. A new forest has grown up in the intervening years, and the view does not show how tall the dam is. (Dmitry Satin)

Another form of obstacle comprised the creation of flooded areas through the use of dams, both improvised and permanent. A tall, concrete flood dam was constructed west of the Leningrad-Viipuri railway on the Peronjoki River. When closed, the dam created a vast flooded area around the railway. A similar dam of wood and earth was built on the Majajoki River west of the Lähde sector. Once the area had been flooded and the first frosts had set in,

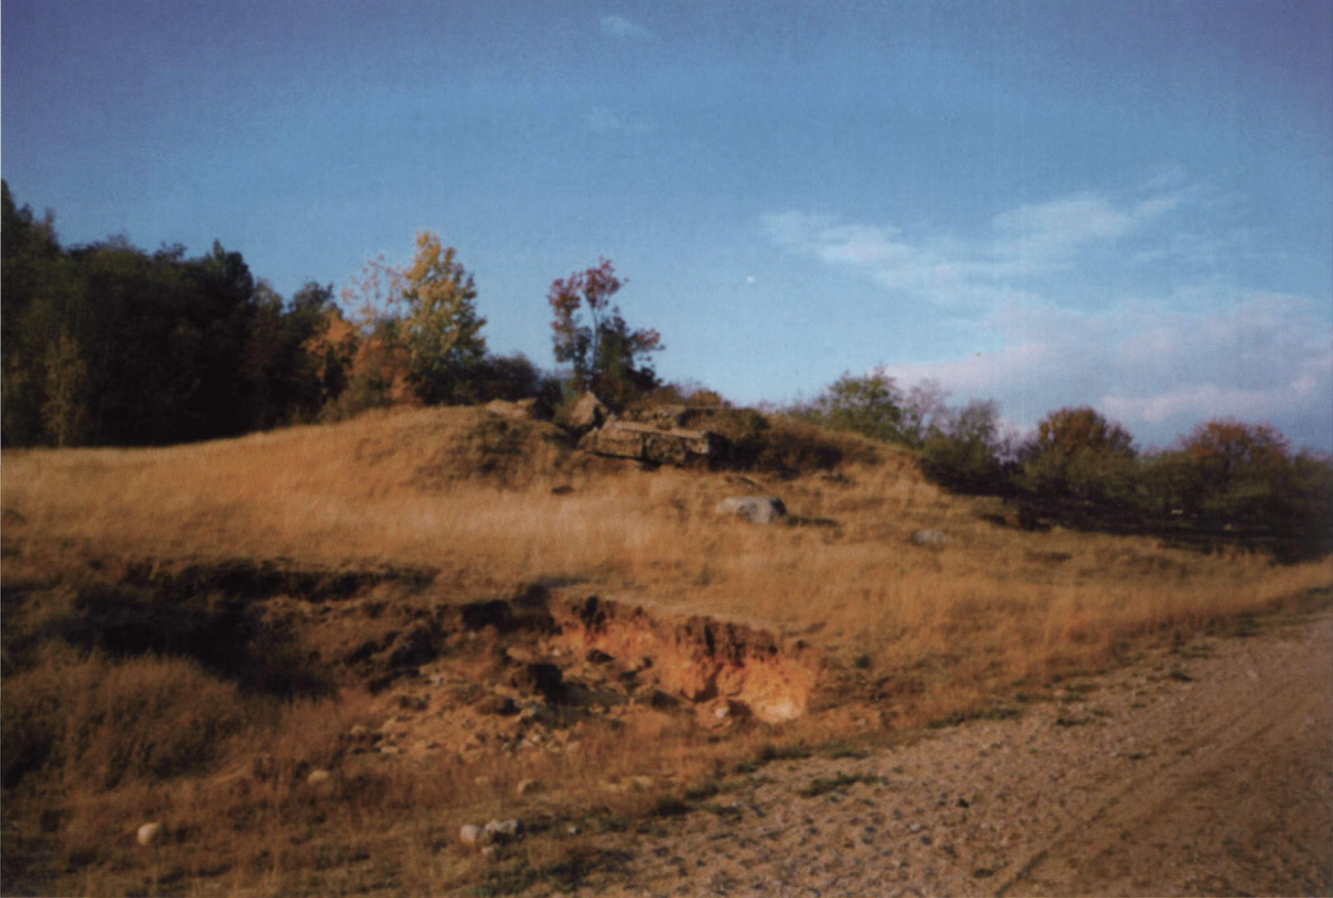
A ruined early bunker in the Karhula sector, north of Karhula village. The old bunkers built in the 1920s were obsolete, and were easily spotted and destroyed by heavy Soviet artillery. (Bair Irincheev)

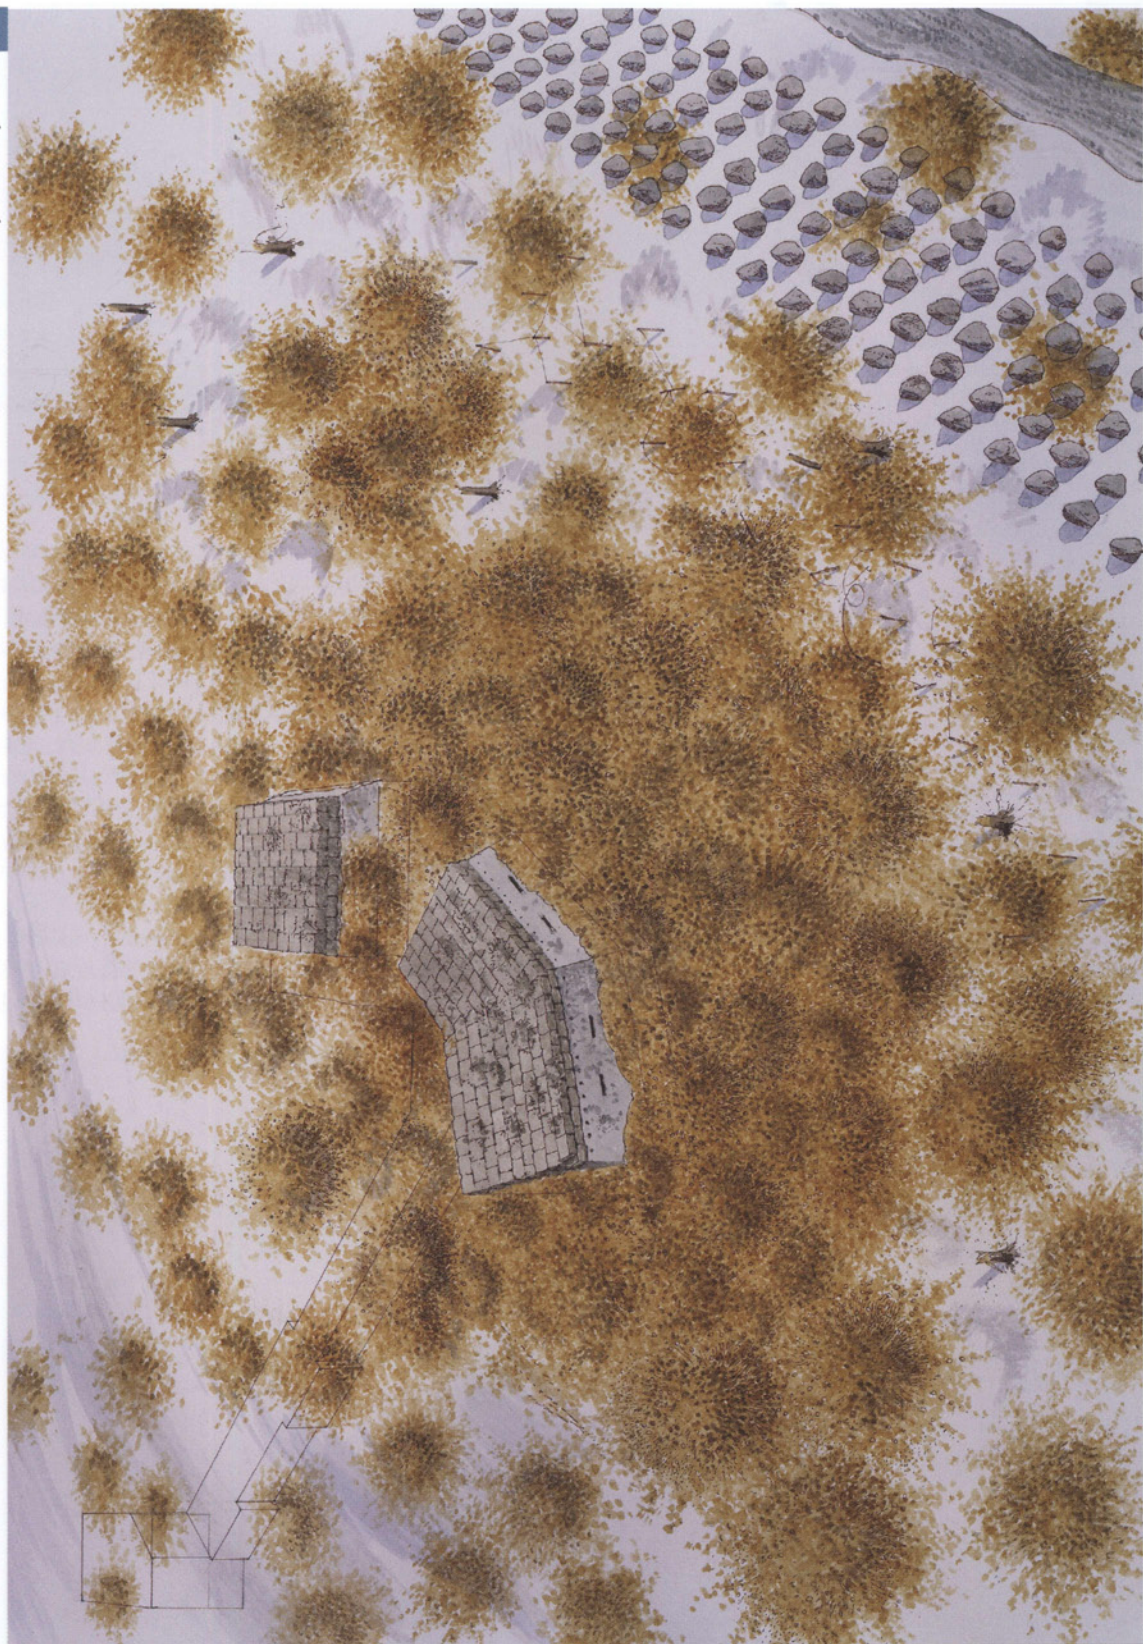
The bunker was bombarded by both direct and indirect fire from the Soviet heavy artillery. The two layers of rocks on top of the casemates are field repairs given to the bunker by Finnish sappers.

Despite heavy bombardment, the bunker remained operational and acted in the defence of the Line until the evening of 15 February 1940, when the withdrawal from the Mannerheim Line began.

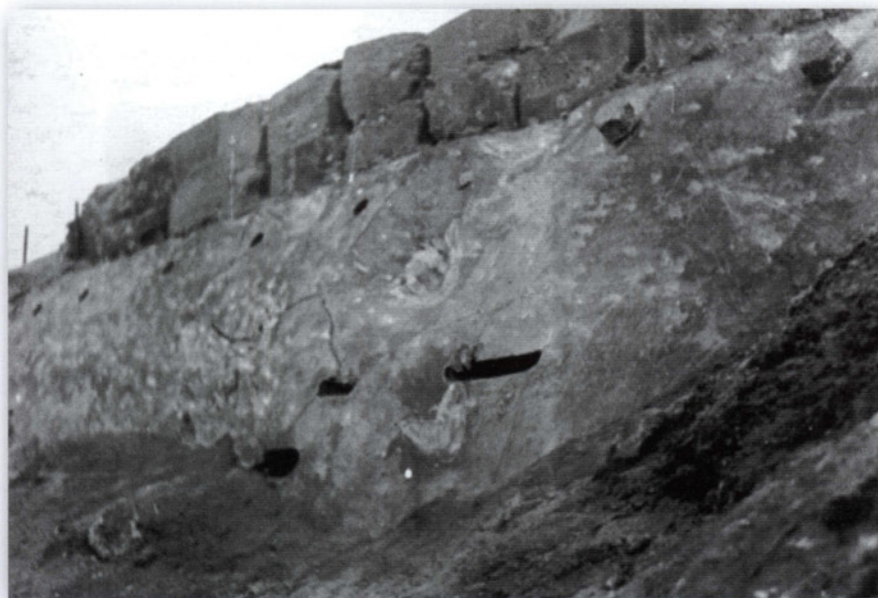
A close-up view of the Ink6 casemate. Note the crack on the frontal armoured plate, missing bolts, traces of direct hits and evidence of field repair. Two observation slits and a gun-port are clearly visible. The gun-port provided only a very narrow sector of fire, of about 60 degrees. (Carl-Fredrik Geust)

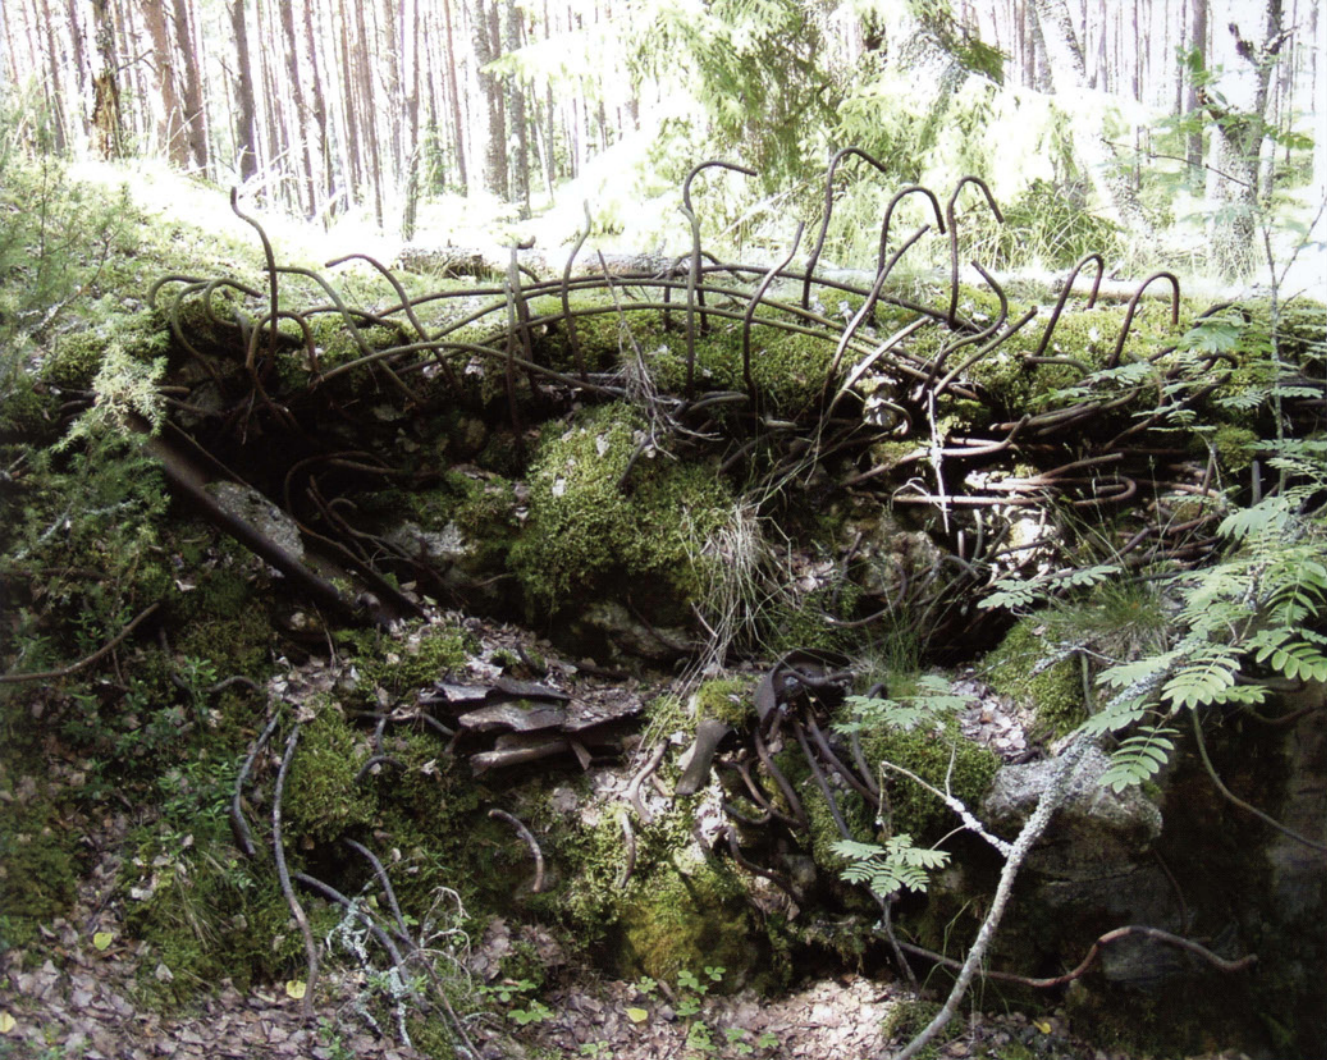
A direct hit on the wall of the Ink7 bunker, which almost penetrated the bunker's shell. Note the H-shaped metal bars used by Finnish engineers to repair the damage. (Bair Irincheev)

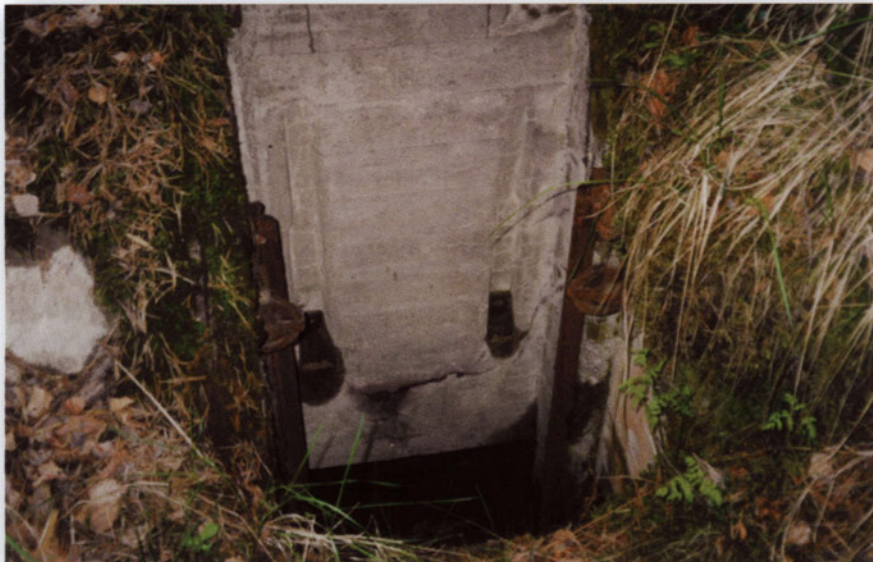
The remains of the armoured wall of one of the eastern casemates of Sk10 'The Ten'. An empty 6-inch shell lies next to the armoured debris. Soon after the photo was taken, the debris was looted for scrap metal. (Bair Irincheev)

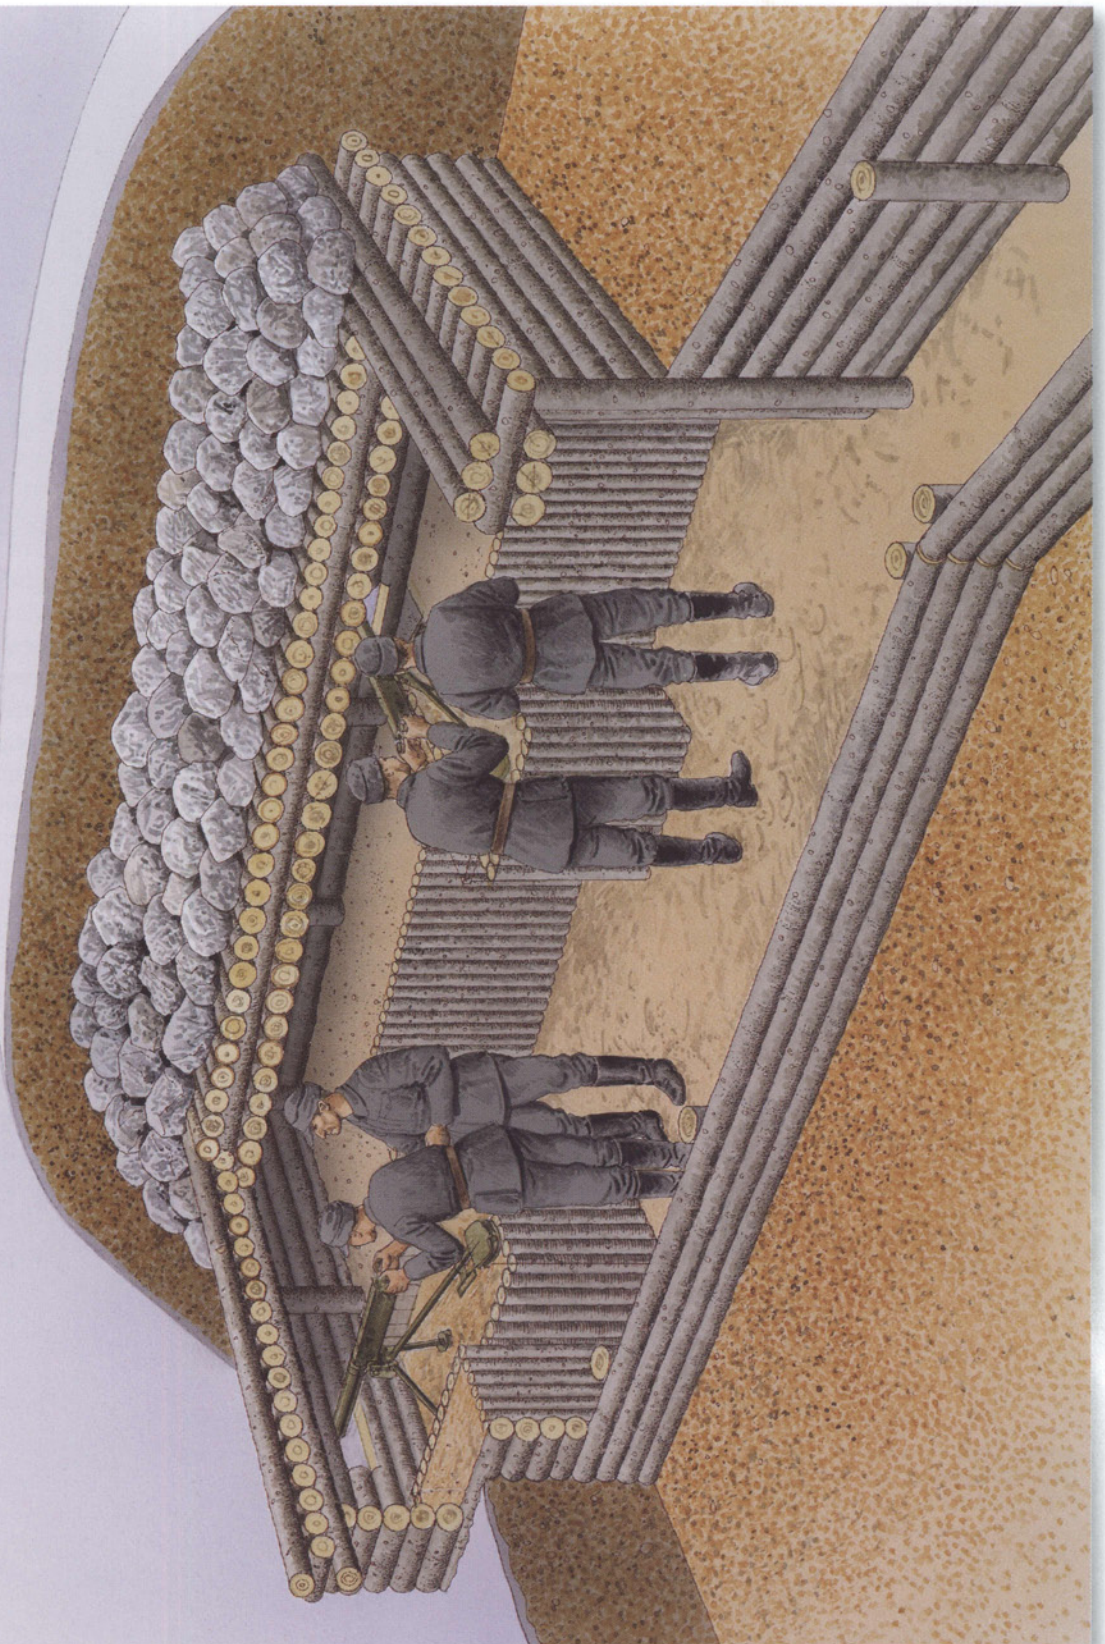
## **D A FINNISH WOODEN MACHINE-GUN BUNKER, IN THE LÄHDE SECTOR**

Although Finnish pre-war fortification manuals had provided drawings for how bunkers of all types should be built, the Finns often constructed the bunkers according to the locally available materials, the terrain features encountered, the presence or proximity of ground water, and common sense. These wooden

bunkers, along with trench works, were the backbone of the Finnish defences in many sectors that lacked concrete bunkers. The bunkers featured two Maxim heavy machine guns, and provided protection against light field guns and Soviet tanks, but were easily destroyed by heavy 6-inch guns when spotted.

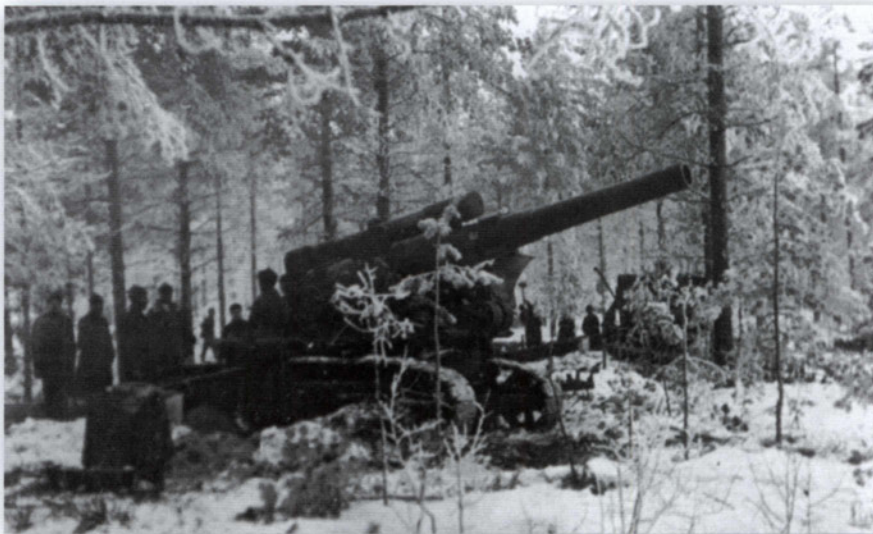
A Soviet B-4 8-inch gun in position on the Karelian Isthmus. A unique feature of the battles on the Mannerheim Line was the deployment of these formidable guns for firing over open sights at a distance of only 700–1,500m from the Finnish bunkers. This demanded careful and secret preparation of a firing position, camouflage, and nerves of steel among the gun crew, who would have to fire at the Finnish fortifications whilst under the rain of mortar fire that the Finns would quickly bring down on these weapons. Red Army soldiers dubbed these weapons 'Karelian sculptors' while the Finns called them 'Stalin's sledgehammers'. (Carl-Fredrik Geust)

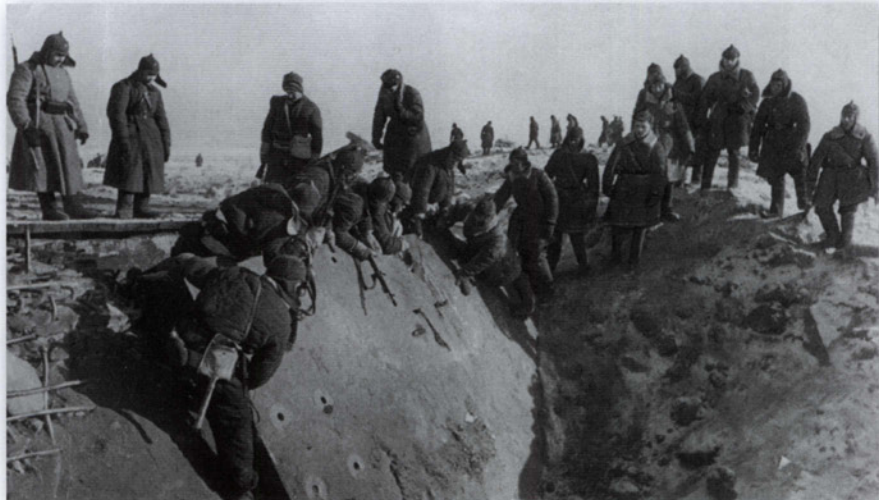
Red Army soldiers study the western, less damaged casemate of the Sjä 'Poppius' bunker in March 1940. Barely visible in the background are the remains of two destroyed medium T-28 tanks. (Bair Irincheev)

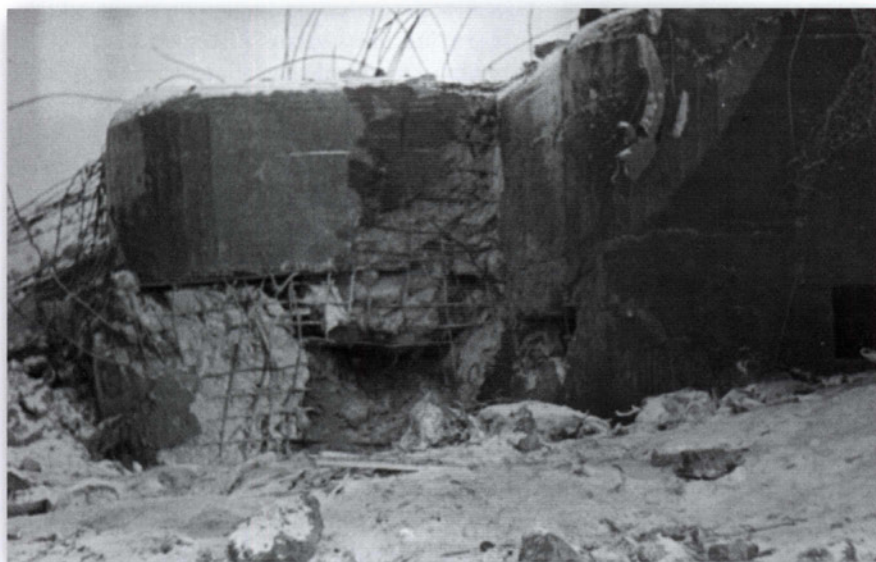
The destroyed eastern casemate of the Sjs 'Millionaire' bunker. Note the remains of the camouflage net in the upper right corner of the picture. (Carl-Fredrik Geust)

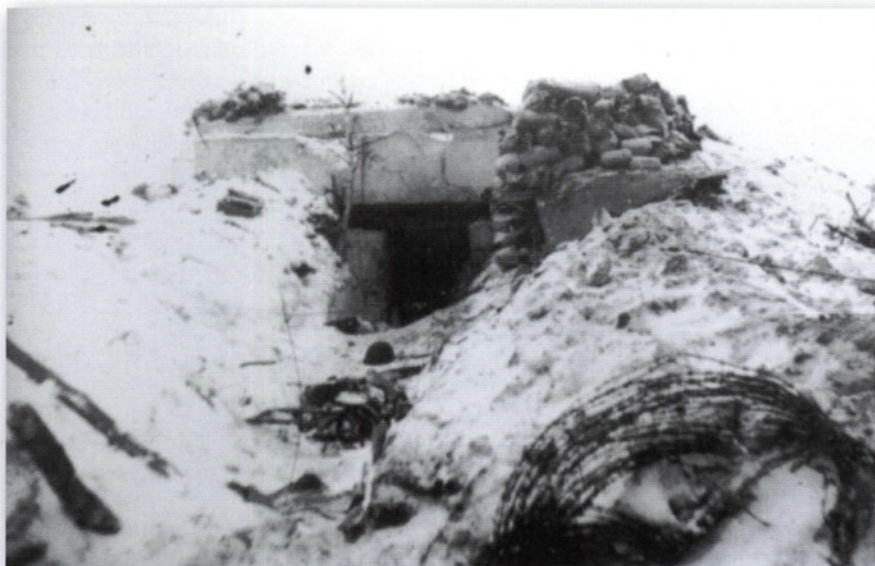
The Sij3 bunker showing field repairs completed by Finnish sappers; sandbags were added to the damaged parts of the bunker. The Red Army artillery pounded the Finnish defences during the daytime, and Finnish sappers repaired them every night in the bitter cold. (Carl-Fredrik Geust)

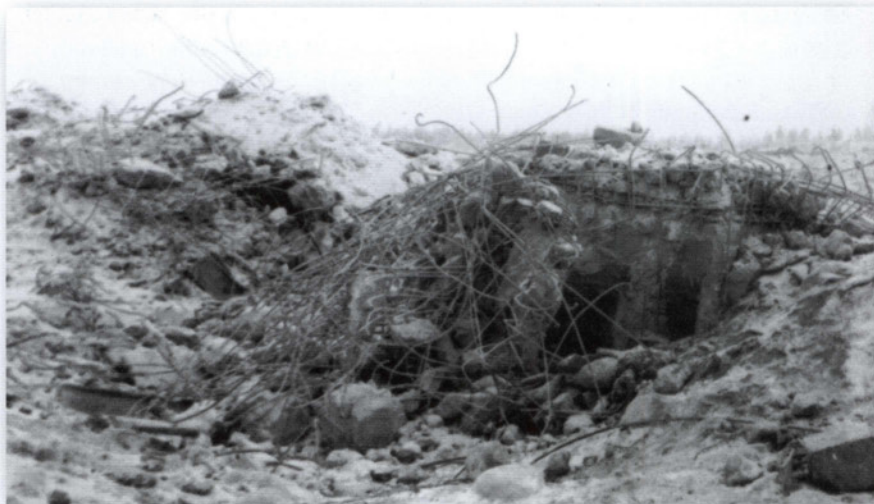
The S3 bunker after demolition by Red Army sappers. Note the H-shaped bars, typical reinforcements for the roofs of bunkers in the 1920s. (Carl-Fredrik Geust)

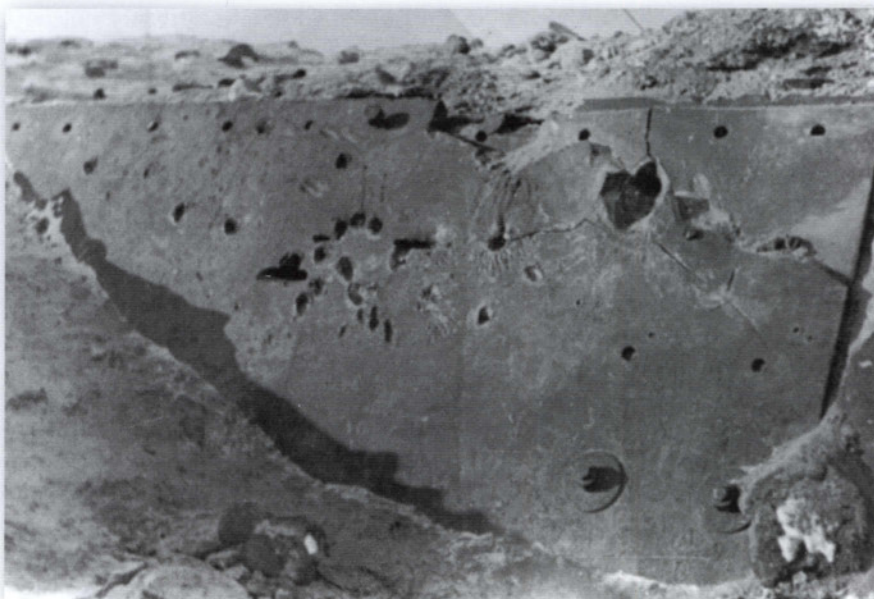
Traces of direct hits from the main guns of tanks, anti-tank guns and heavy artillery mark the frontal wall of the eastern casemate of the S34 'Poppius' bunker. Soviet artillery Sergeant Egorov was awarded a Gold Star of Hero of the Soviet Union for firing at the casemate at almost point-blank range, after all his fellow crew members were killed or wounded. (Carl-Fredrik Geust)
